Bala Cynwyd Library

Walk-Thru

16 September 2009

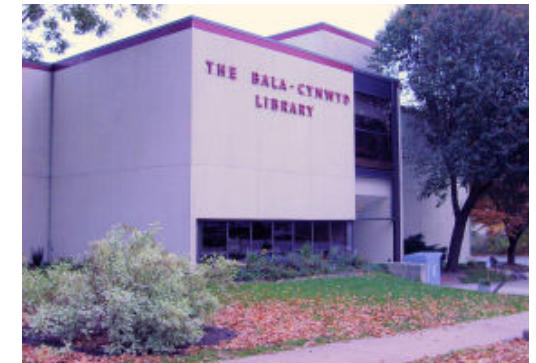
HVAC SYSTEM must be replaced within next 2 years (2009 - 2011).

- *The 5 Multi-zone and 2 single-zone rooftop air handling units are past their normal lifecycles and are in poor condition. They require substantial maintenance to keep them running, and could fail at any time.*
- *Boiler, pumps & heat exchanger are at end of service life and must be replaced within 4 years.*
- *Major duct work modifications from partitioning the building resulted in less efficient air distribution (PAI memo 4/93).*

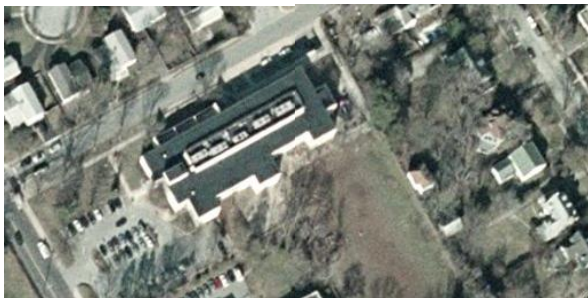
ROOF needs major repair or replacement.

- *Persistent leaks even after repairs in late winter 2009.*
